TEST REPORT

Report No.: HC80163/2023

Product Description: NETWORK CAMERA
Style/ Item No.: MS9321-EHV-V2/ No.1
Manufacturer/ Vendor: VIVOTEK INC.
Country of Origin: Taiwan
Quantity: Total 1 piece
Testing Period: Aug. 17, 2023

1. Impact Test

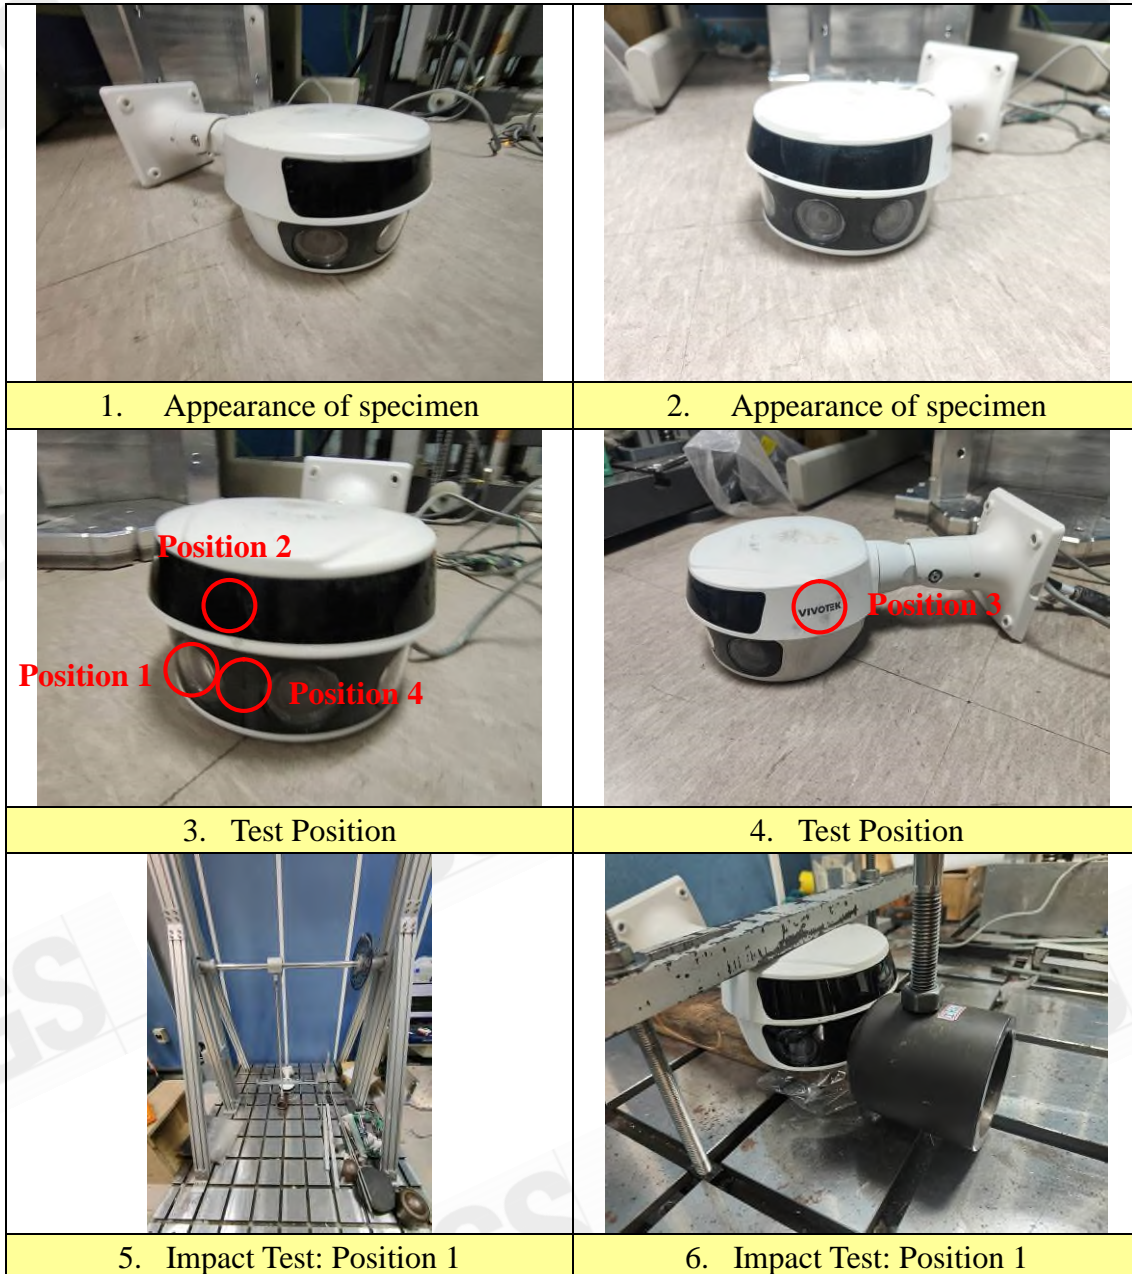
Test Photos:

Test method: IEC 62262 Edition 1.1: 2021--IK10 and client's request
Sample Condition: Operating
Impact energy: 20 Joule
Mass: 5 kg
Impact height: 400 mm
Test Position: Position 1 ~ Position 4 (As shown in photo 3, 4)
No. of Impact: 1 impact/ position
Testing device: As shown in photo 5 ~ 12
